USAAML TECHNICAL REPORT 64-13

CYCLOIDAL CAM TRANSMISSION

PHASES II AND III

CONTRACT DA 44-177-TC-651
WESTERN GEAR CORPORATION
SYSTEMS MANAGEMENT DIVISION

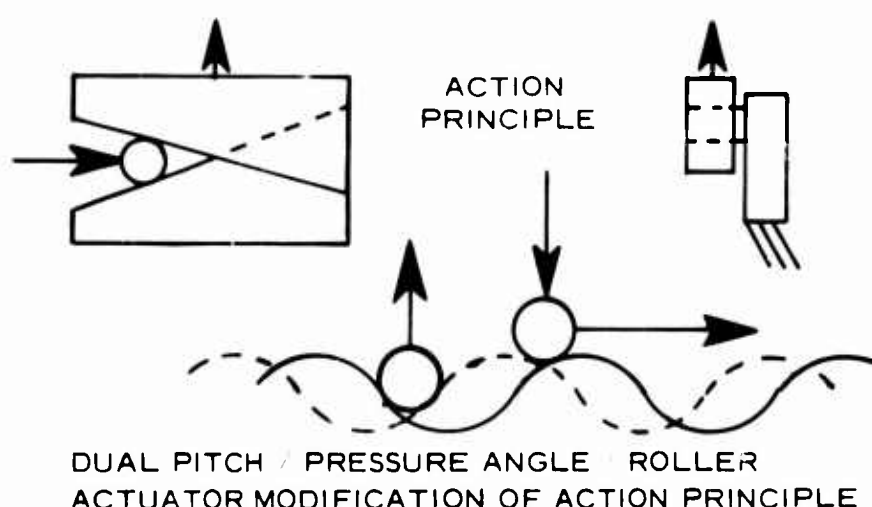
Figure 1. Basic Kinematics of Cam Action

Differential drives permitting high speed reduction do not operate in the same manner as the normal tangential load/radius proportioning used in conventional gearing. Essentially, the inclined plane or wedge principle is used, permitting large mechanical gains proportional to the wedging angle involved (Figure 1).

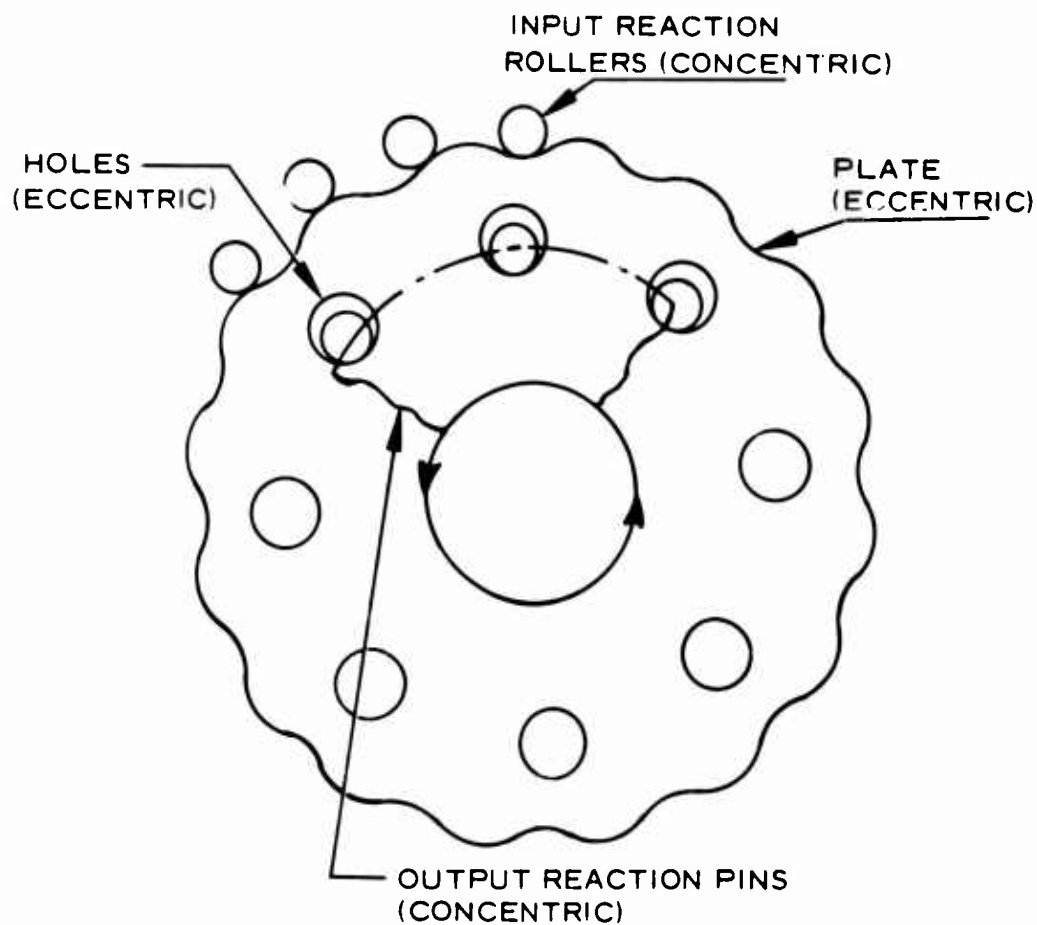
Figure 2. Cycloidal Cam Principle

the radius generating an epicycloid and is generated by the same generating circle, rolling circle, and instant center as its companion epicycloid, is generally used. This curve eliminates the sharp cusp at zero pressure angle with the follower and greatly reduces peak angular acceleration of the followers or reaction rolling members. (Figure 2).

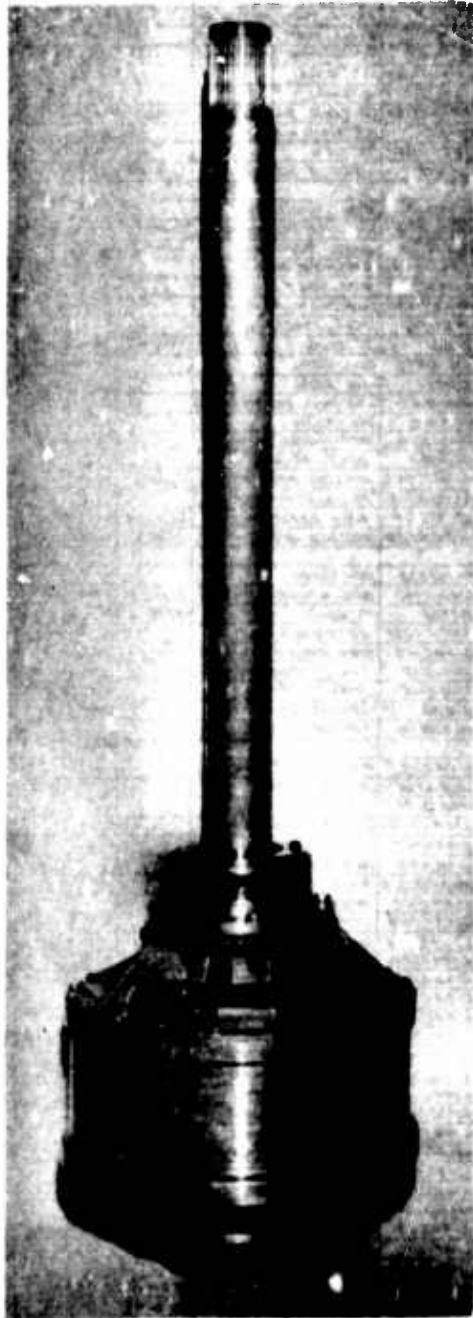
Figure 3.
Cycloidal Cam Transmission
S/N 101
Model 6144R149

The crankshaft of the cycloidal cam transmission has two pairs of throws, each pair being 180 degrees out of phase with the other pair. Each throw is eccentric by 3/16 inches. The throws are in pairs in order to balance the centrifugal and bearing loads in the system. Each throw is attached to the geometric center of a cam plate through roller bearings. The outer periphery of the four cam plates have 19 lobes which are cycloidal in form. The lobes of the cam plates contact reaction pins at positions where the eccentric of the crank throw extends the cam plate to its maximum distance from the center of rotation of the crankshaft. Twelve reverter pins which are connected to the output shaft cage are positioned through holes in the cam plates. The ends of each reverter pin are connected to the output shaft cage member on either side of the cam plate assembly. The speed reducing effect is produced by rotating the crankshaft inside the four cam plates. The eccentrics on the crankshaft force the cam plates outwardly, causing the lobes to react against the reaction members in a wedging action.

own centers by the amount of one lobe pitch per revolution of the crankshaft. Since there are 19 lobes on the cam plates and 20 reaction pins, the cam plates are advanced $1/19$ of a revolution for every revolution of the input shaft. Since the output shaft cage is driven through the reverter pins by the cam plates, the output shaft or mast therefore only rotates $1/19$ of a revolution for every revolution of the input shaft producing a 19:1 speed reduction.

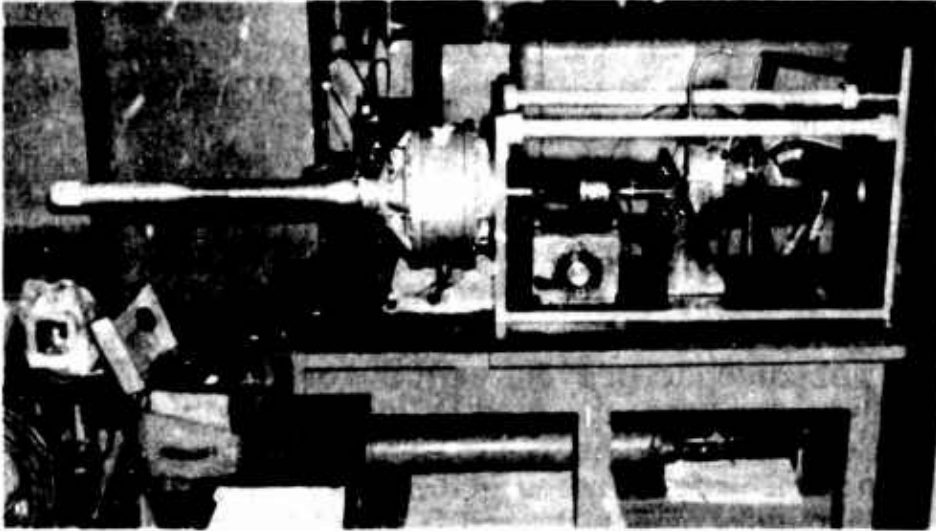
Figure 5. Run-in test stand with transmission S/N 101 mounted for horizontal operation.

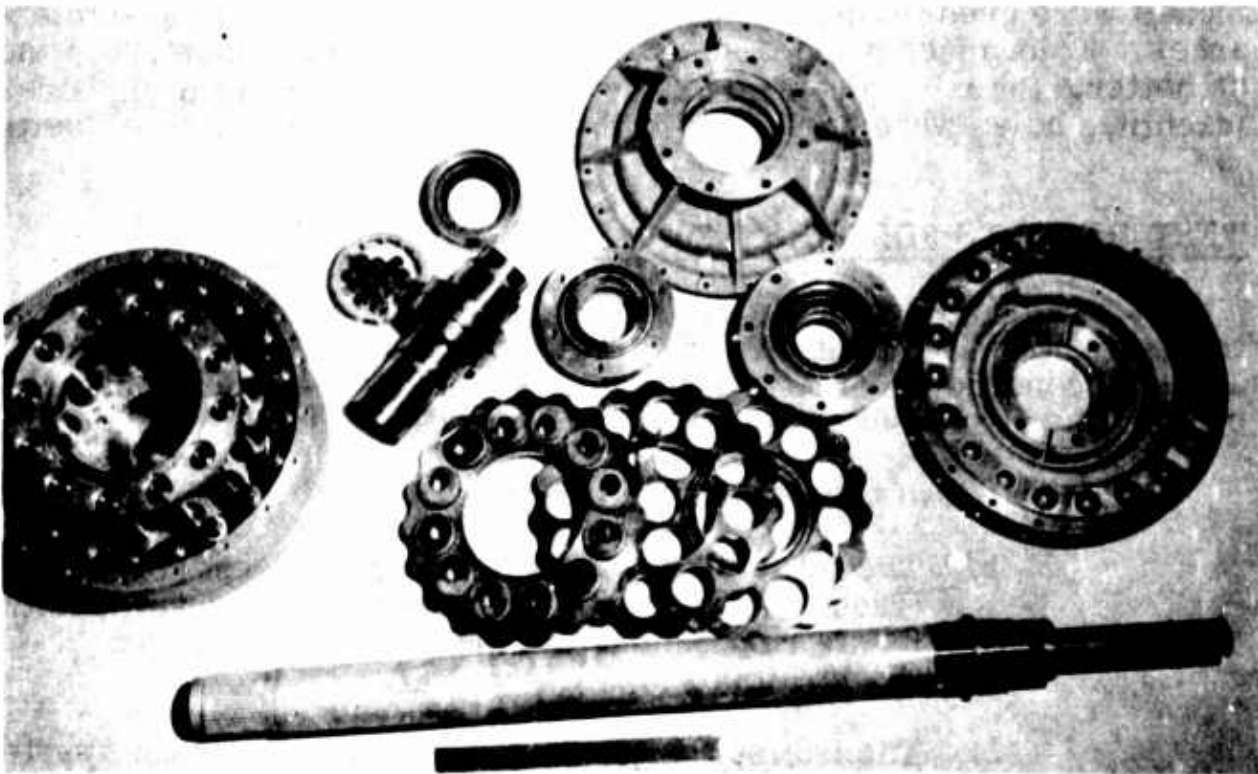
Figure 6. Partial disassembly of transmission S/N 101.

Assembly procedure (Figure 6, page 9) is based on starting from the input side of the unit and building it up cam plate by cam plate. The output mast is subassembled with its bearings and inserted into the transmission as the last item.

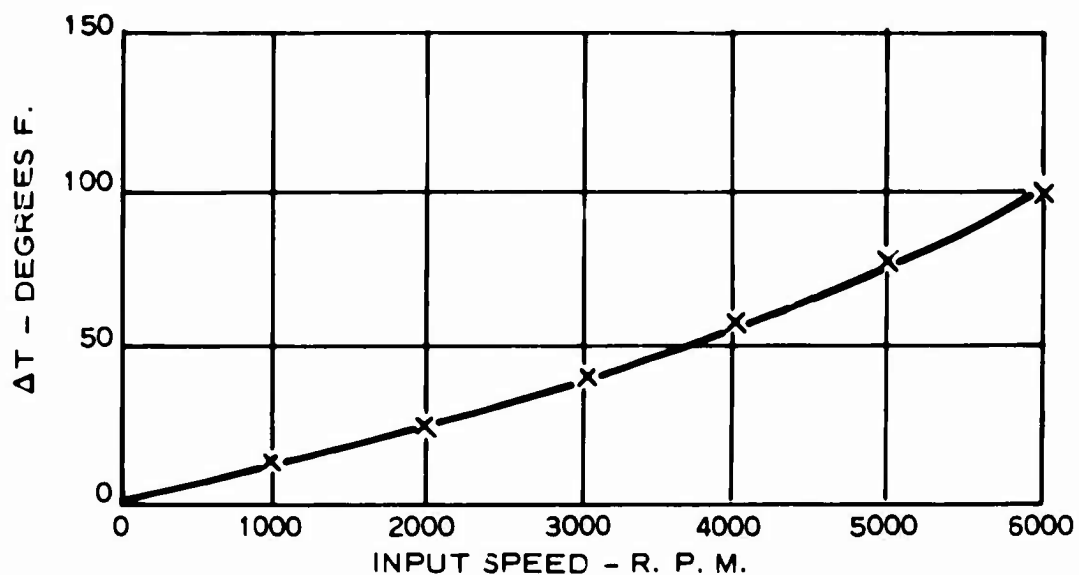
Figure 8. Stabilized temperature runs for horizontal operation with no external load applied to the output shaft. Lubricant: MIL-L-6086 Light, Flow: 2.0 gpm.

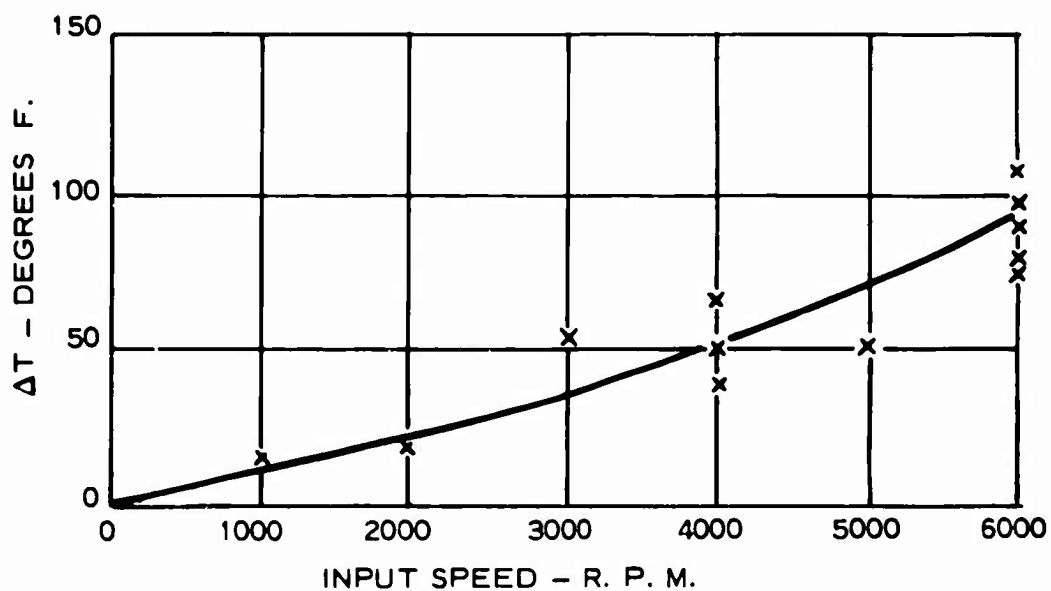
Figure 9. Stabilized temperature runs for vertical operation with no external load applied to the output shaft. Lubricant: MIL-L-6086 Light, Flow: 2.0 gpm

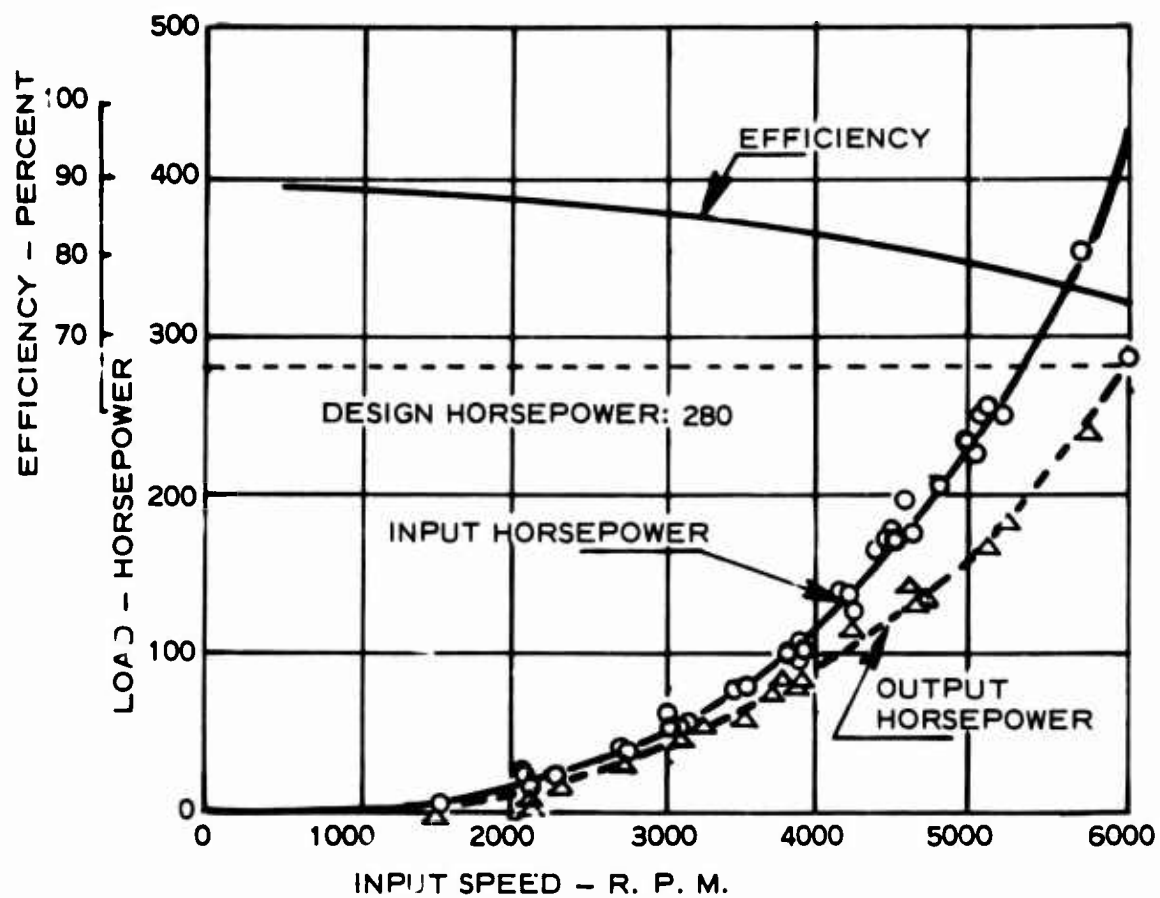
Figure 12. Composite Performance for Transmission S/N 101.

Development testing under loading conditions revealed that the transmission was capable of transmitting the design horsepower of 280. The composite performance of the various load runs are shown on Figure 12, page 20. The mechanical efficiency during the load runs

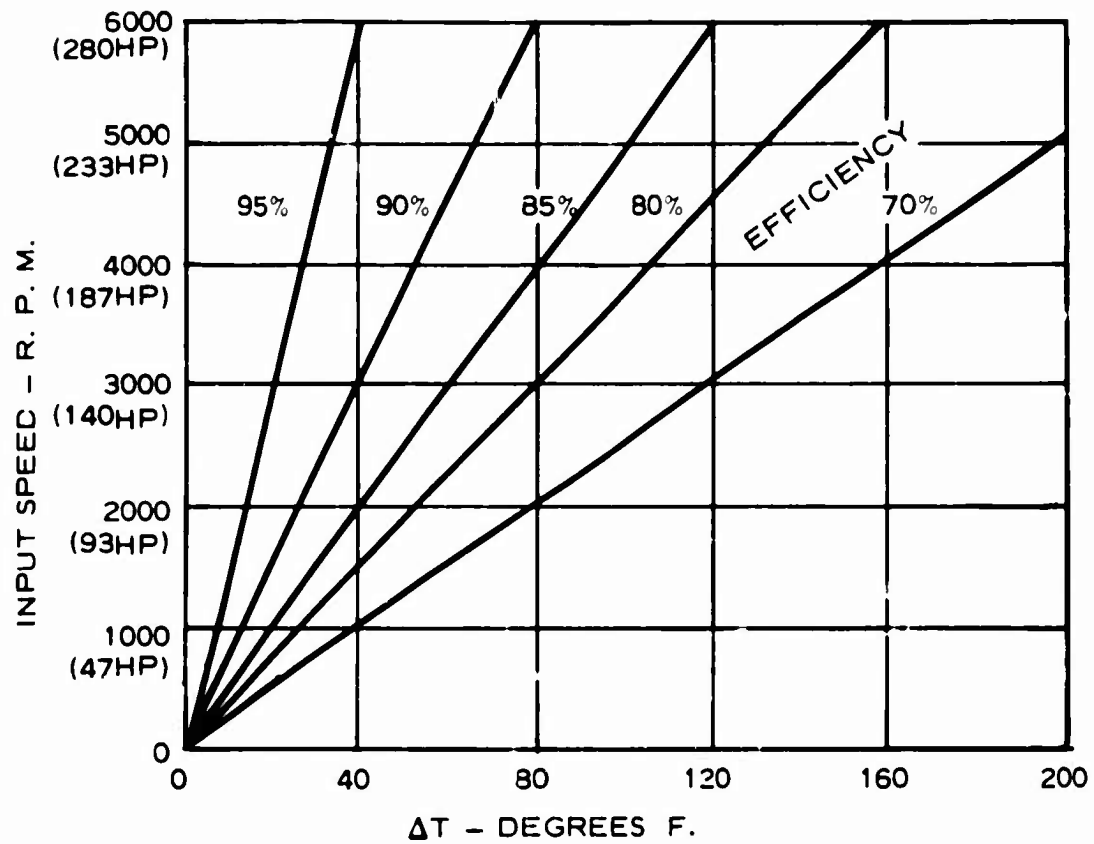
Figure 13. Theoretical Heat Balance Graph.
 This graph is based on the assumption that 80% of the heat loss is taken in the lubricating oil. The flow conditions were 3 gpm.

To better illustrate the heat balance approach, a graph (Figure 13) was plotted showing horsepower vs ΔT with efficiencies superimposed.

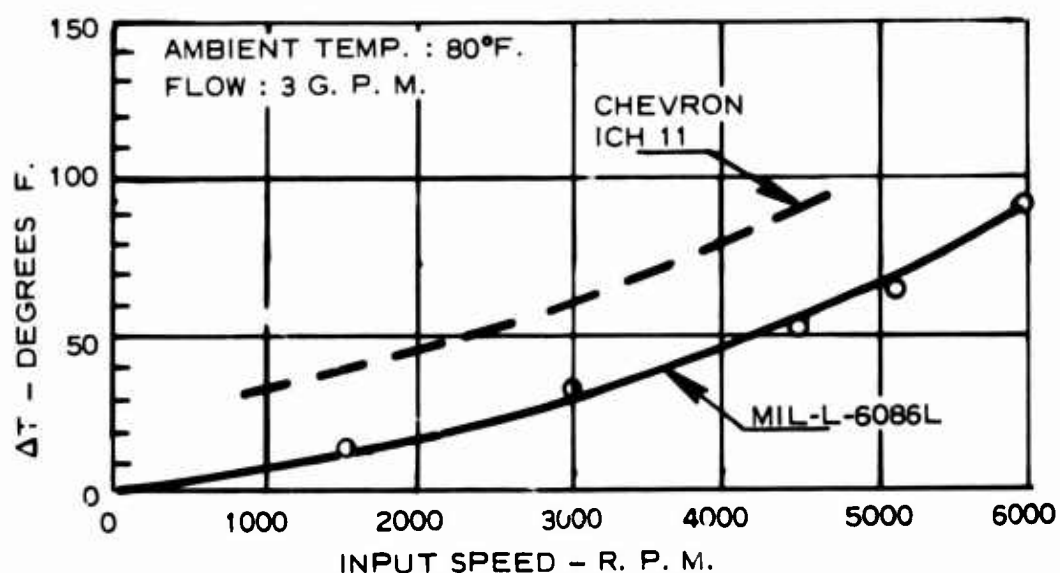
Figure 14. Stabilized temperature load runs for two types of transmission lubricants.

A stabilized temperature load graph for two types of transmission lubricants is shown in Figure 14. The MIL-L-6086 light oil is considered the better oil for the application involved. Therefore, testing with Chevron 1CH 11 was discontinued.

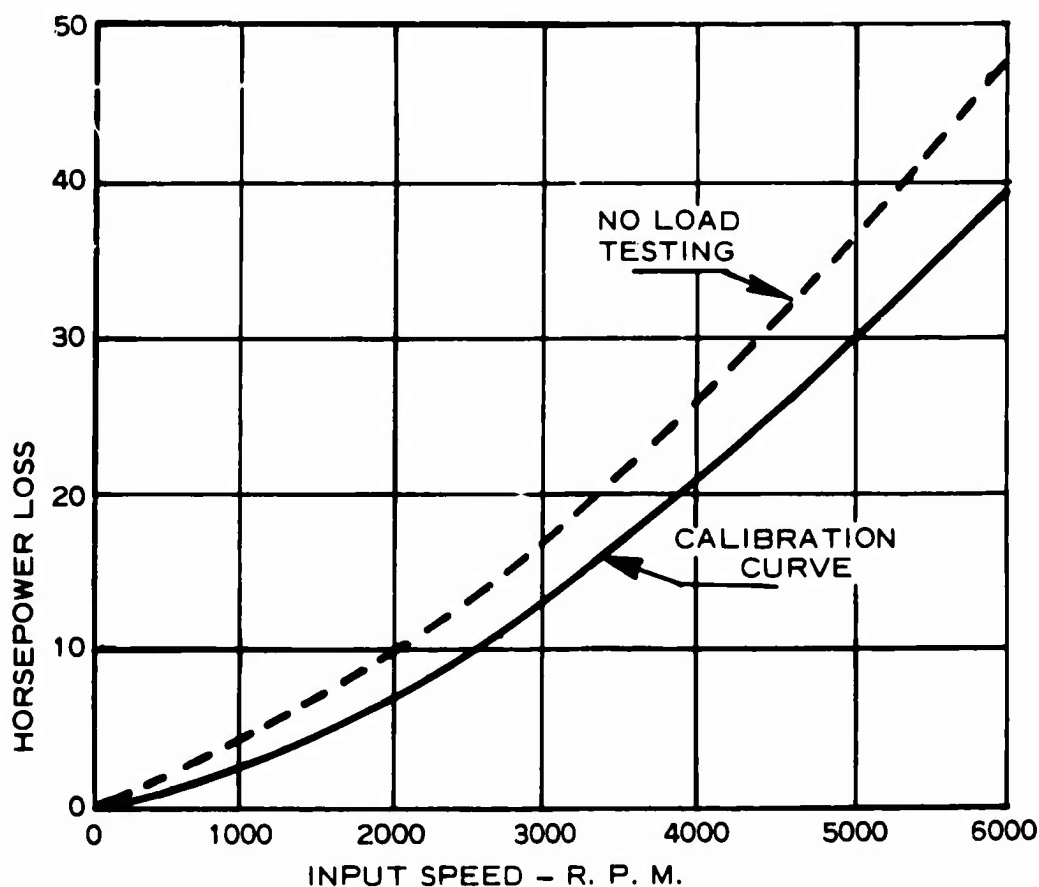
Figure 15. Calibration curve for step up gear box, Model 114H577, on input drive side. The graph is based on tests for the rated load condition of 1800 HP at 7200 RPM. The overall efficiency is approximately 90% which includes coupling loss.

This value is from the calibration curve, Figure 15.

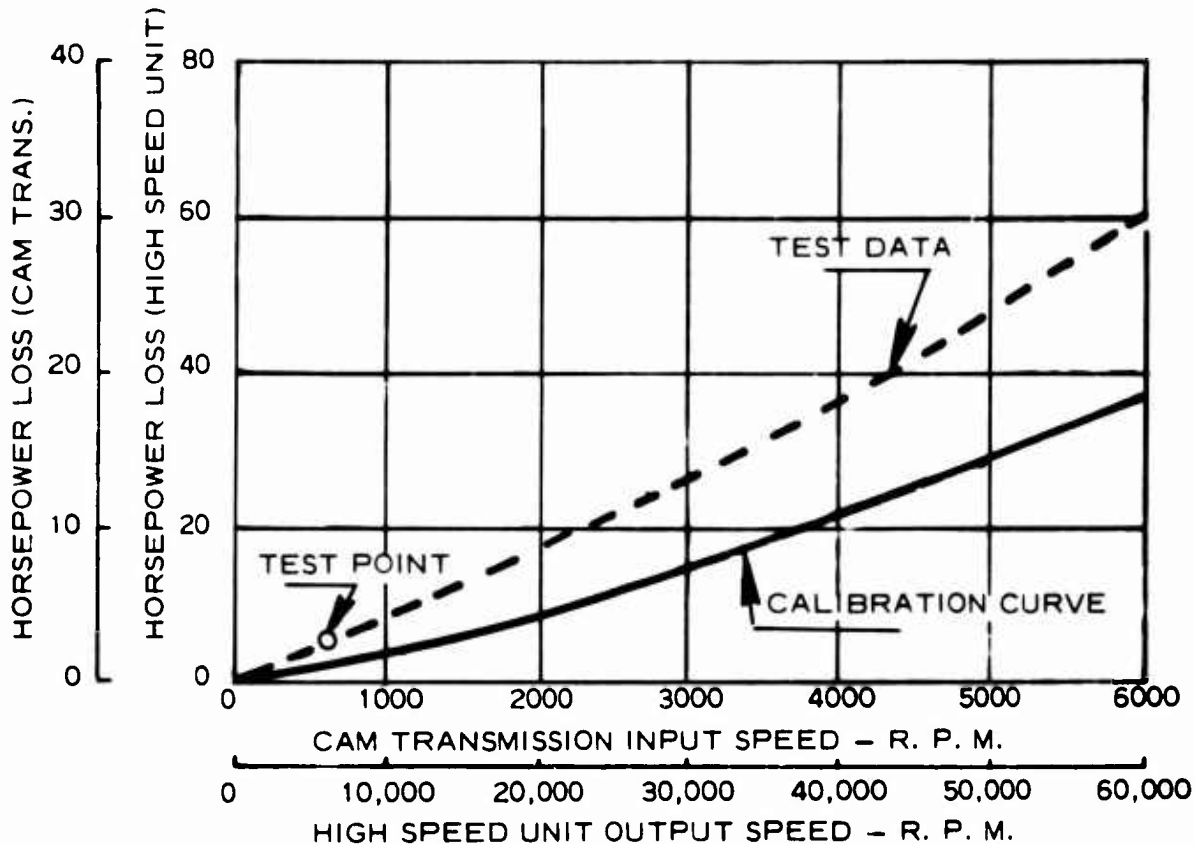
Figure 16. Calibration curve for high speed unit, Model 3600R0 on output load side. The graph is based on tests for the rated load condition of 600 HP at 60,000 RPM. The overall efficiency is approximately 97% which includes coupling loss.

This value is from the calibration curve, Figure 16.

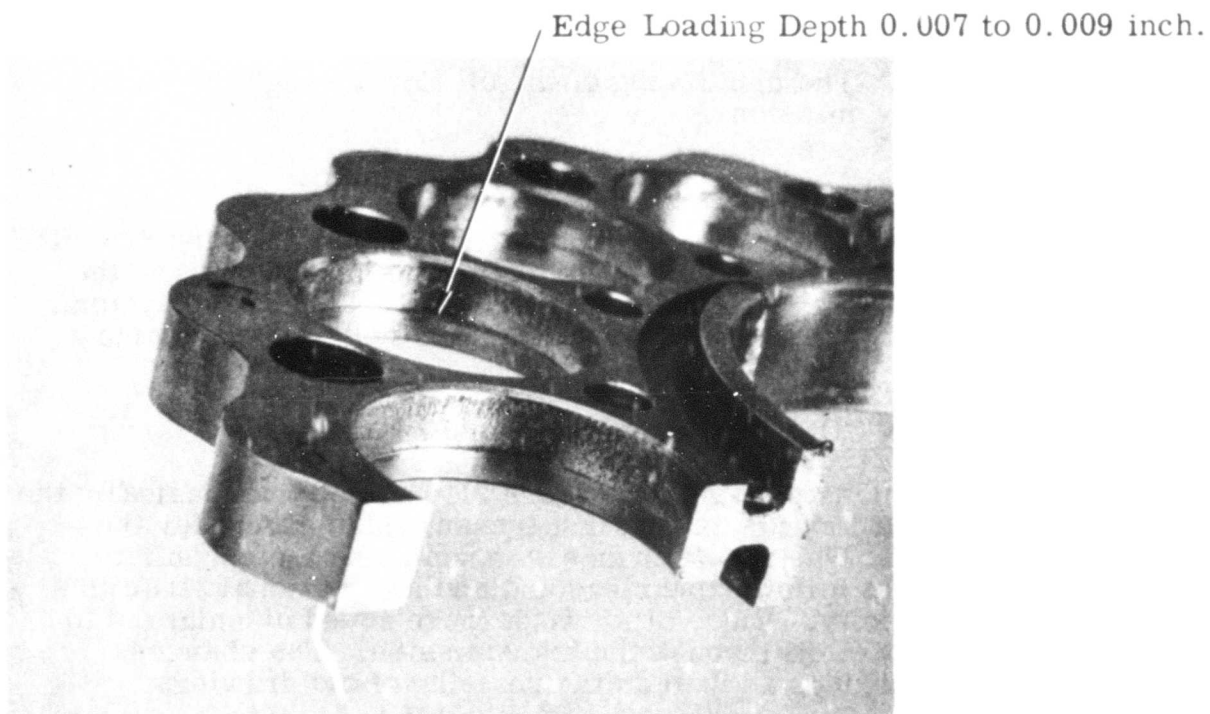
Figure 17. Cam plate #1 from test transmission S/N 101.
View showing reverter bearing load pattern.

1. The torsional deflection in the reverter system was beyond the recommended design limits for the roller bearing deflections.
2. The torsional windup from the output load created an unequal load distribution across the cam plates such that one cam plate was overloaded about two and a half times its normal loading.
3. The main losses of the transmission were traced to the eccentric bearings in the reverter system. These losses developed from the bearings going through dead center position creating a wedging action or fighting condition (Figures 17 and 18, page 27).

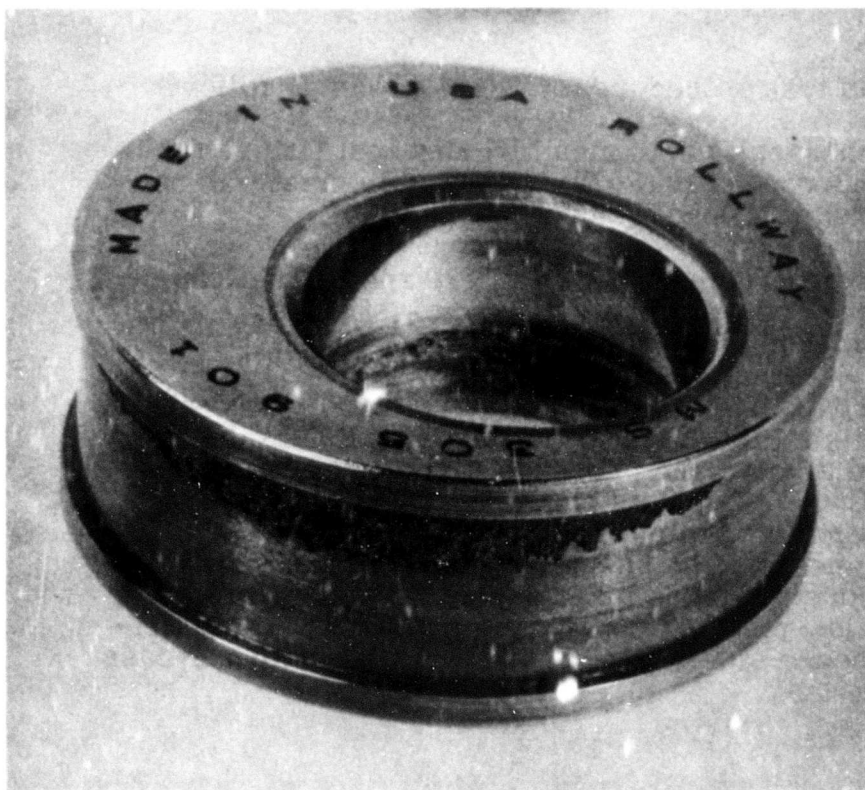
Figure 18. Reverter bearing from test transmission
S/N 101. View shows edge loading on inner
race of the bearing.

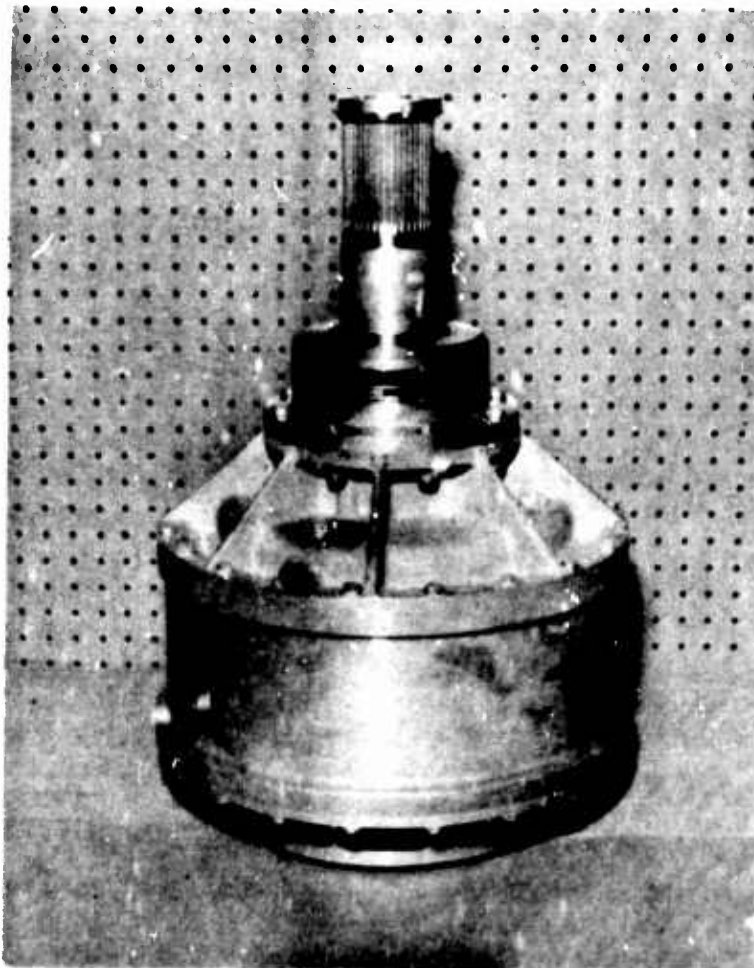
**Figure 19. Cycloidal cam transmission
model 6144R231 S/N 101.**

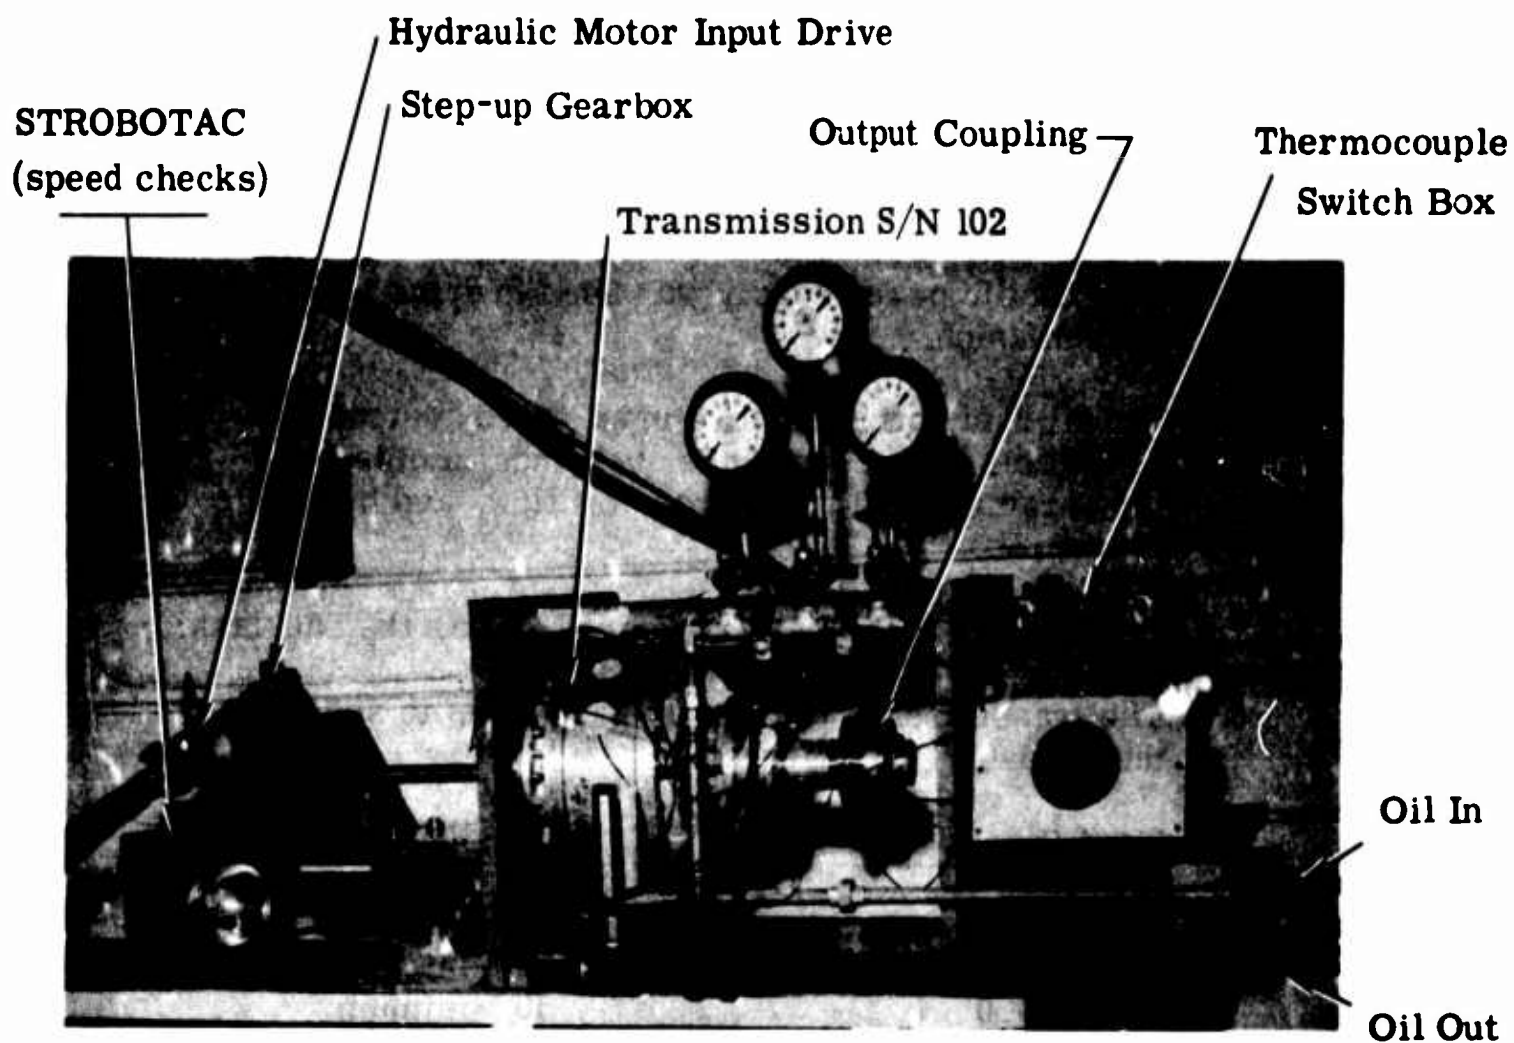
Figure 22. Run-in test stand for transmission S/N 102.

1. The transmission was mounted on a test fixture for horizontal operation. The output stub mast was not connected to a load (Figure 22, page 31).
2. The transmission requires an external lubricating system. The system used during testing is shown in Figure 23, page 31.
3. The three inlet oil lines and the two drain lines were connected to the lubrication system. Each inlet oil line had a valve and pressure gage installed as close to the transmission as possible. Each line was of maximum size with a minimum of restrictions. The outlet lines were connected to the scavenge pump with provisions for three magnetic plugs, a temperature gage, flow meter, and heat exchanger. On the inlet or pressure side was a 10-micron filter with a bypass valve to tank.

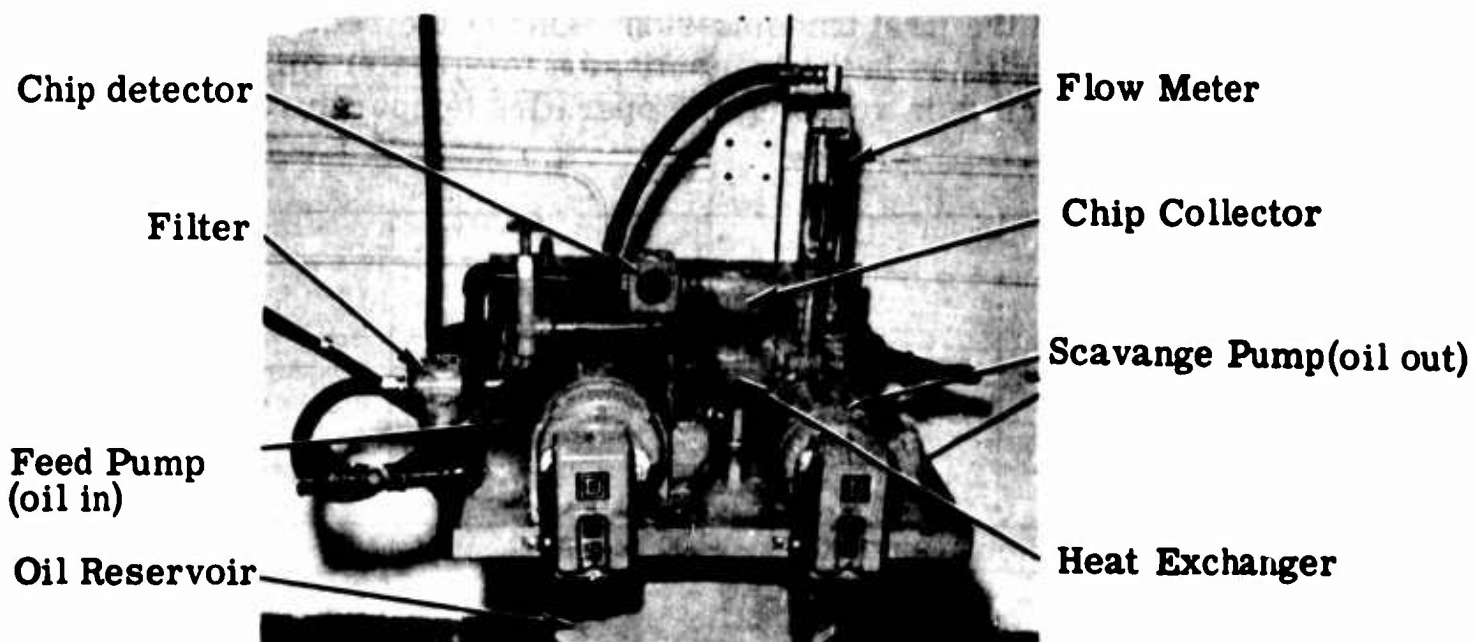
Figure 23. Lubrication system for test transmission S/N 102.

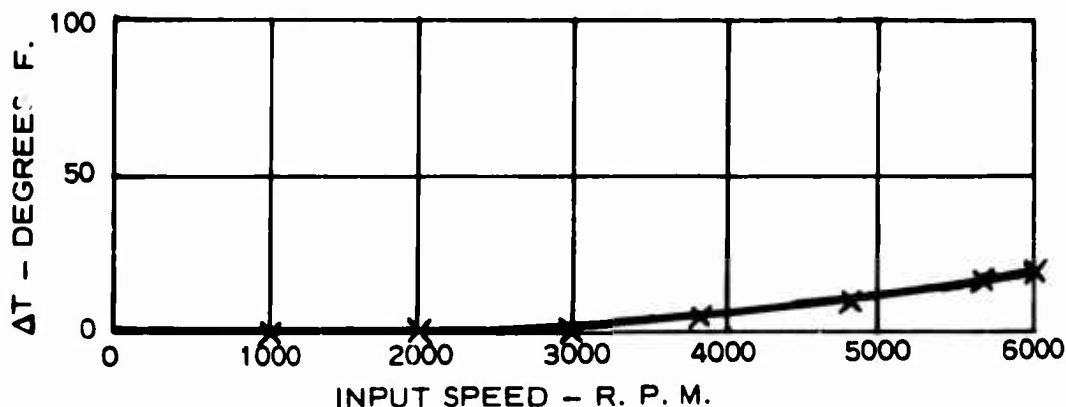
Figure 24. Stabilized temperature runs for horizontal operation of transmission S/N 102 with no load applied to the output shaft. Lubricant: MIL-L-7808D, Flow: 7.3 GPM.

The primary purpose of the "no-load" testing was to monitor the oil flow through the transmission to see the change of operating temperatures from the first transmission. One of the redesign changes was enlarging oil orifices in the transmission for greater oil flows. This was very effective in reducing the operating temperatures . (Figure 24).

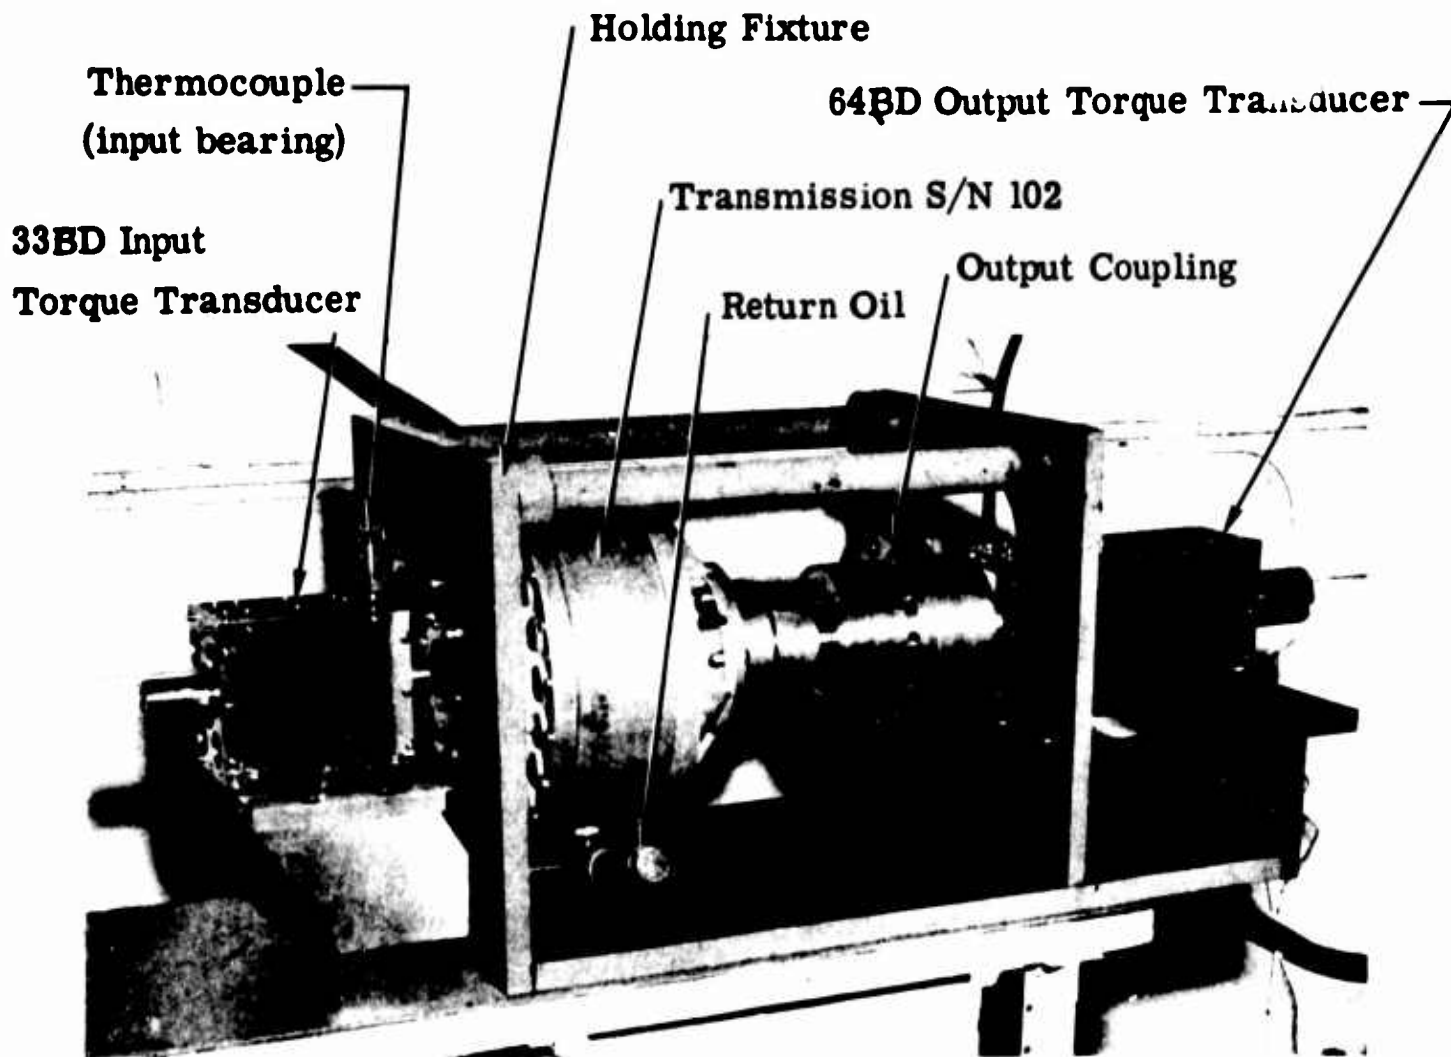
Figure 25. Assembled transmission load fixture.

1. The transmission was mounted on the test fixture in the horizontal position with torque transducers aligned and mounted on the fixture (Figure 25, page 34).

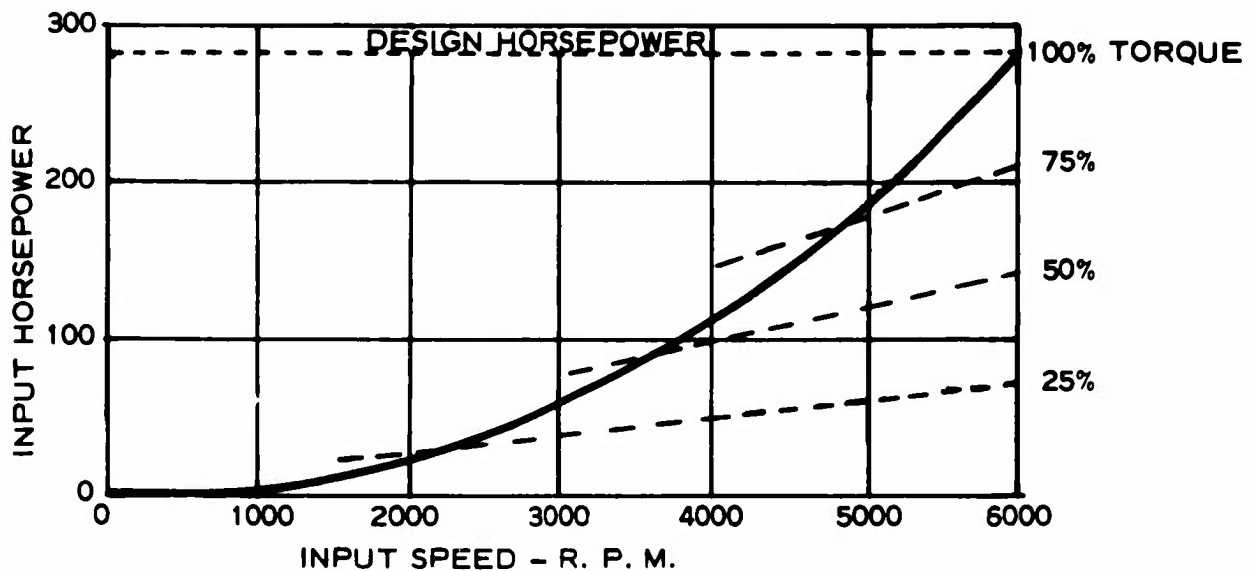
Figure 26. Loading Spectrum

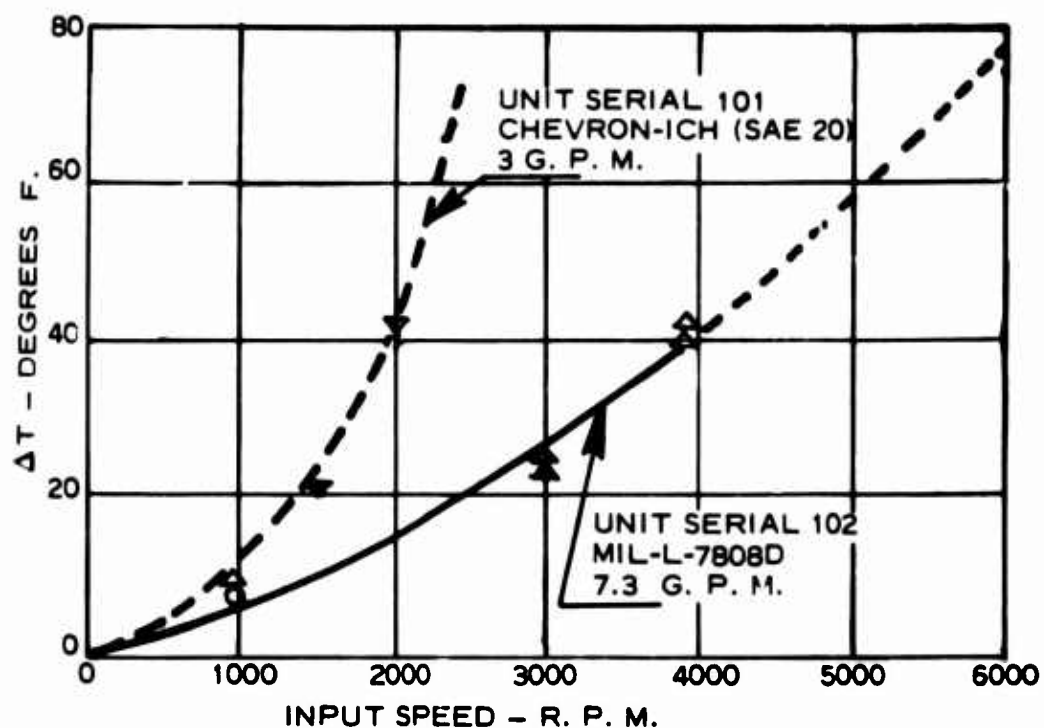
Figure 27. Stabilized temperature load runs for transmission in horizontal operation. Lubricants were not cooled. Loading: Water pump 2 x 3 x 10-1/2 H-SMU.

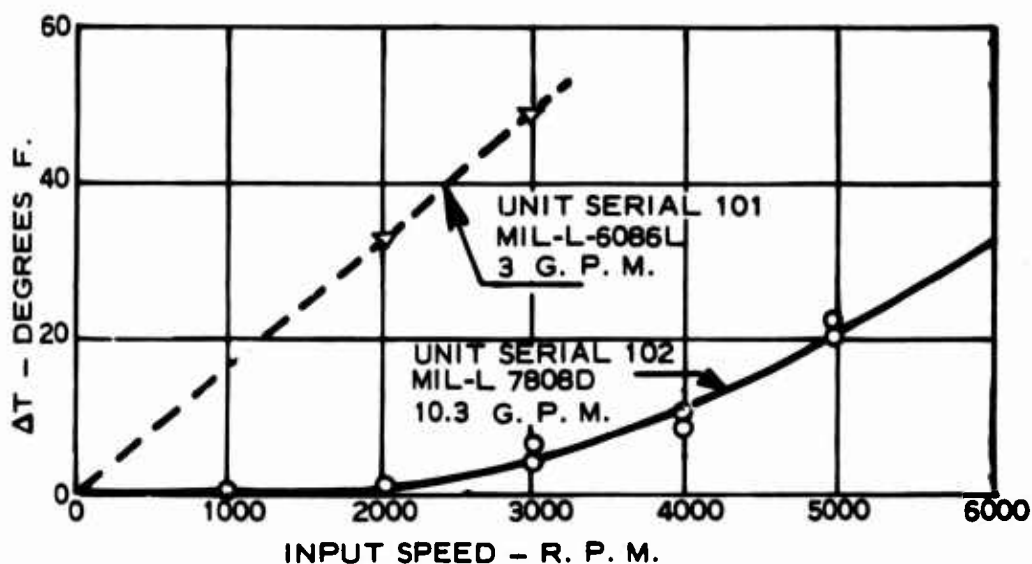
Figure 28. Stabilized temperature load runs for transmissions in horizontal operation. Lubricants were cooled. Loading: two stage water pump 3 x 4 x 11-1/2.

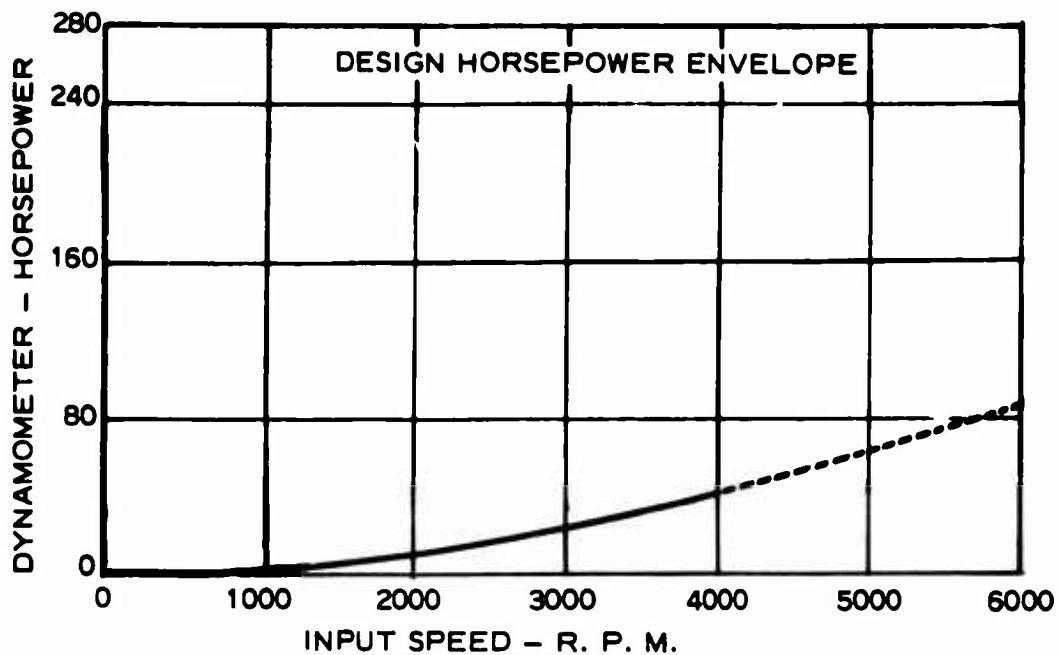
Figure 29. Input power. Load testing with water pump 2 x 3 x 10-1/2 H-SMU.

Figures 29, and 30, page 38 reflect the loading spectrum accomplished. Two loading pumps of different capacity were used in order to cover the range of torque settings and speeds desired, as outlined in the load test procedure. Torque settings of 25 percent, 50 percent, and 75 percent were achieved during the testing. The last setting of 100 percent was not accomplished because of excessive transmission wear requiring the testing be stopped.

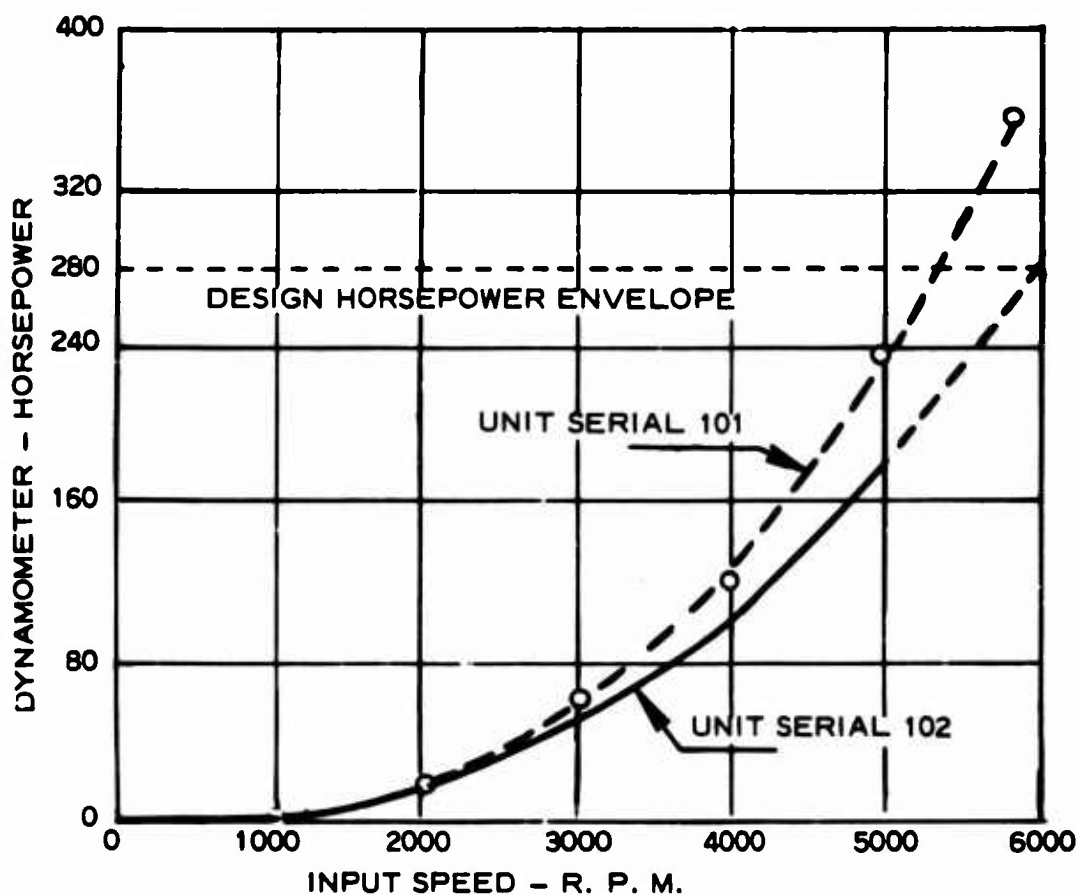
Figure 30. Input power. Load testing with two stage water pump 3 x 4 x 11-1/2.

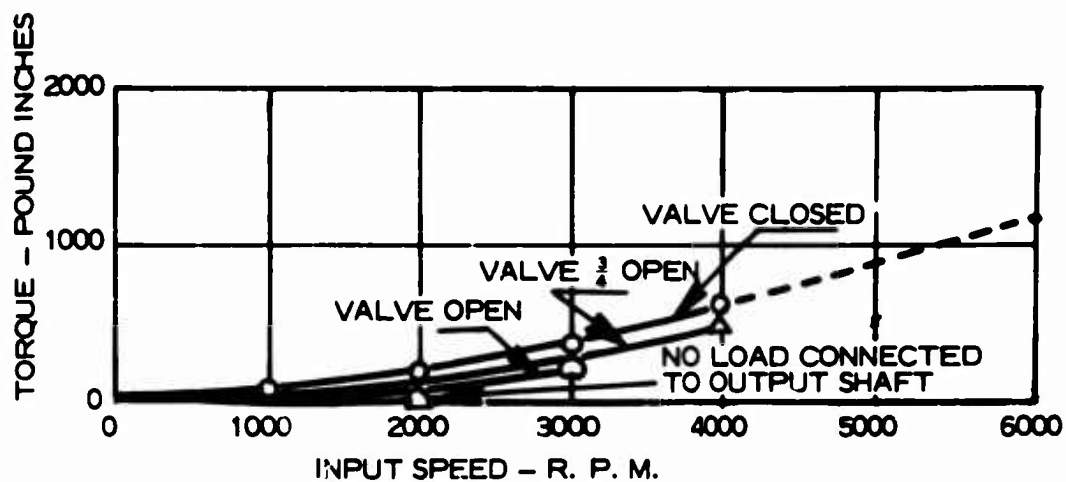
Figure 31. Input torque. Load testing with water pump 2 x 3 x 10-1/2 H-SMU. Torque measured with 33 β_D transducer.

Figures 31, 32, 33 and 34 pages 39 and 40, are torque curves generated from transducer data. Special attention is directed toward the transducers. The two transducers were developed specifically for this application. While commercial transducers now on the market could also have generated the same data, the βD transducers
